Manhole Inspection Summary

Manhole # S150__024MH

Location Address: **2677 WILKENS-ST. BENEDICT**

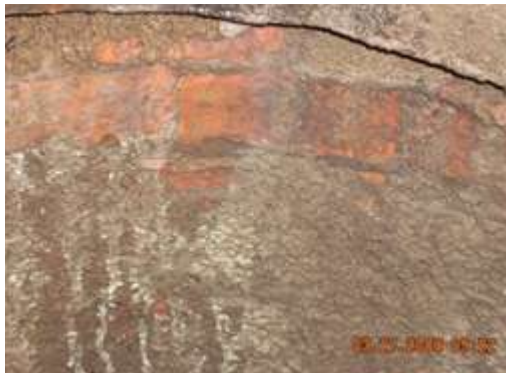
Defect 2

Infiltration: ☐ None ☐ Joint ☐ Cracks ☐ Mortar ☐ Roots ☒ **Wall**

Chimney INFILTRATION

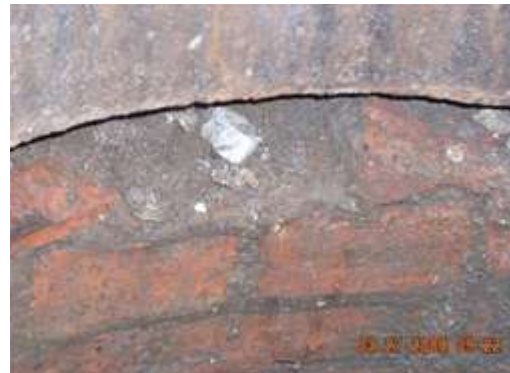
Defect 1

Condition: ☐ Sound ☐ Cracked ☐ Root Intrusion ☐ Loose Brick ☒ **Deteriorated**

Chimney DETERIORATION

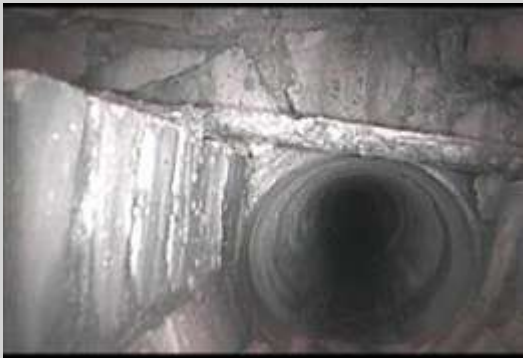
12 O'Clock Outflow

8 in. Circular Gravity Sewer
Pipe Out @ 12 O'Clock

Pipe Height: **8.4** (in.) Rod and Bar (Angled)
Pipe Material: **Clay** ☐ Pipe Lined
Invert Depth: **8.32** (ft.) Flow Characteristics: **Slow**
Deposits: ☒ None ☐ Mud ☐ Sludge ☐ Debris ☐ Grease
Silt Depth: **0** (in.) Deposits Extent:
Infiltration: **None** Pipe Seal Cond: **Sound**

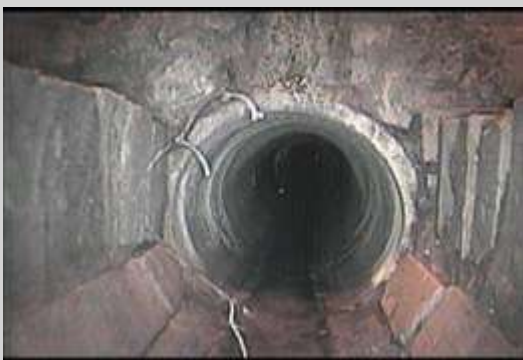
6 O'Clock Inflow

8 in. Circular Gravity Sewer
Pipe In @ 6 O'Clock

Pipe Height: **8.4** (in.) Rod and Bar (Angled)
Pipe Material: **Clay** ☐ Pipe Lined
Invert Depth: **8.12** (ft.) Flow Characteristics: **Slow**
Deposits: ☒ None ☐ Mud ☐ Sludge ☐ Debris ☐ Grease
Silt Depth: **0** (in.) Deposits Extent:
Infiltration: **None** Pipe Seal Cond: **Sound**
